Manhole Inspection Summary

Manhole # S17EE2011MH

Insp Date: **10/25/06 10:38 PM**

Location Address: **1623 KELLY AVE**

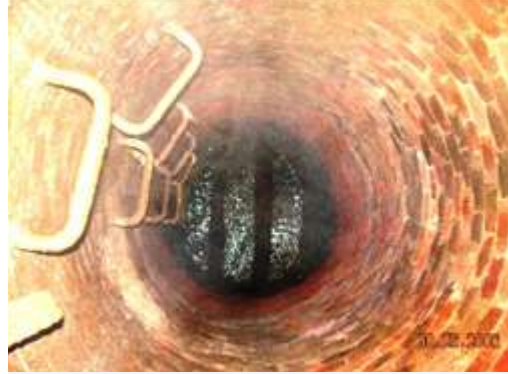
Top View

Adjustment infiltration. Evidence of surcharge. Corroded steps.

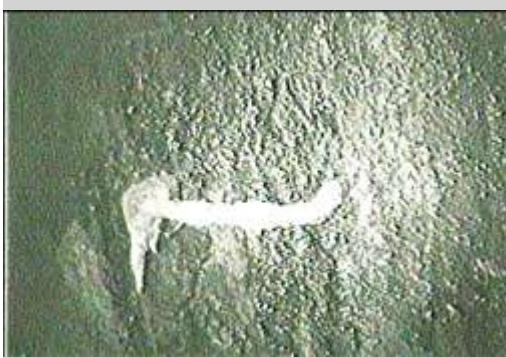
Defect

Surcharge ☒ **Evidence Of Surcharge** Depth: **10** (ft.) ☐ Active Surcharge Present

Evidence of surcharge.

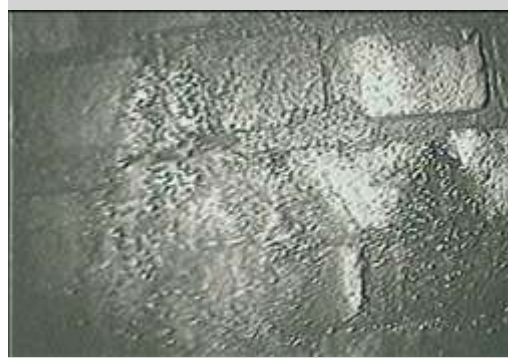
Defect

Infiltration: ☐ None ☐ Joint ☐ Cracks ☒ **Mortar** ☐ Roots ☒ **Wall**

Corbel infiltration.

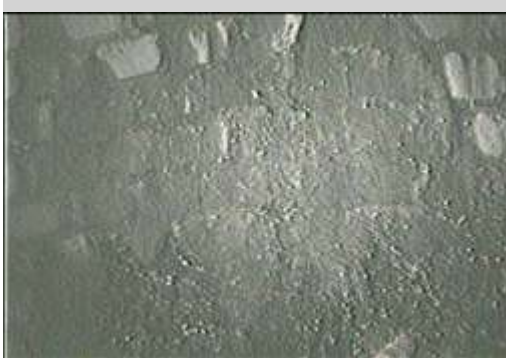
Defect

Condition: ☐ Sound ☐ Cracked ☐ Root Intrusion ☐ Loose Brick ☒ **Deteriorated**

Infiltration: ☐ None ☐ Joint ☐ Cracks ☒ **Mortar** ☐ Roots ☒ **Wall**

Barrel deterioration and infiltration.

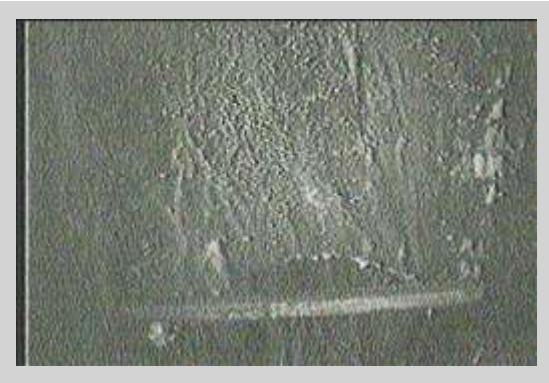
24 in. Circular Gravity Sewer Pipe Out @ 12 O'Clock

Invert Depth: **20.37** (ft.) Flow Characteristics: **Slow**

Infiltration: **None** Pipe Seal Cond: **Unknown**

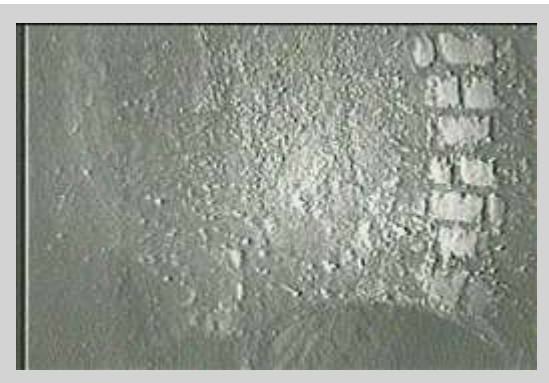
24 in. Circular Gravity Sewer Pipe In @ 6 O'Clock

Invert Depth: **20.15** (ft.) Flow Characteristics: **Slow**

Infiltration: **None** Pipe Seal Cond: **Unknown**
